# FRAUNHOFER INSTITUTE FOR INTEGRATED SYSTEMS AND DEVICE TECHNOLOGY

# LOCK-IN THERMOGRAPHY

Non-destructive localization of electric active defects

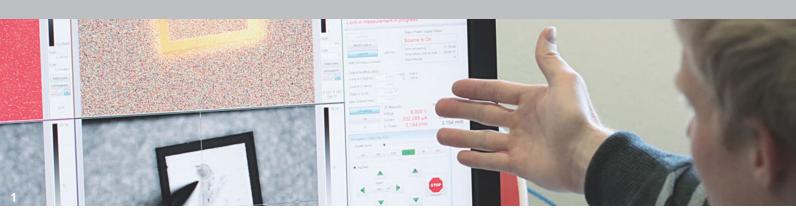
1 Lock-In Thermography in action

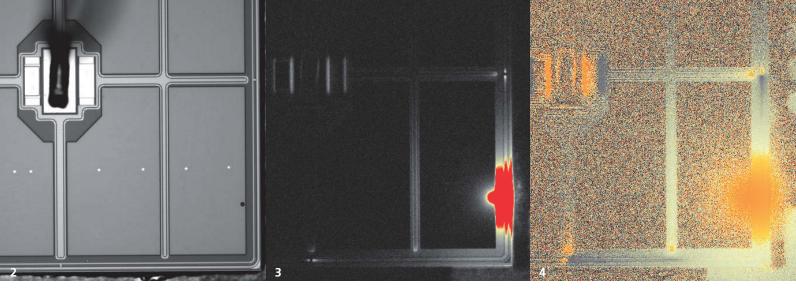
- After fabrication, a power module failed the final electrical quality test (e.g. gate-emitter leakage current)
- Lock-in thermography helps to detect which semiconductor is responsible for the leakage current and determinds the exact position of the defect on the device
- Next step consists of removing bond wires and aluminium-metalization of the semiconductor followed by a second lock-in thermography analysis to get the micro scale location of the defect
- An additional investigation can be a focused ion beam investigation with scanning electron microscopy to detect the cause of failure (e.g. damaged gate structure)

2 Optical Microscopy of IGBT
3 Lock-In Thermography Amplitude of IGBT
4 Lock-In Thermography Phase of IGBT

- The device under test is pulsed with the rectangular voltage by arbitrary lock-In frequency (typical: 1 to 25 Hz)
- Electrical defect dissipate thermal power
- Thermal power heats up the surface
- Measurement of infrared signal with infrared camera
- Acquisition of amplitude image as well as resulting time dependent step response (phase image)
